Operating Experiences of FBTR

Indira Gandhi Centre for Atomic Research (IGCAR), Kalpakkam, India

Abstract:

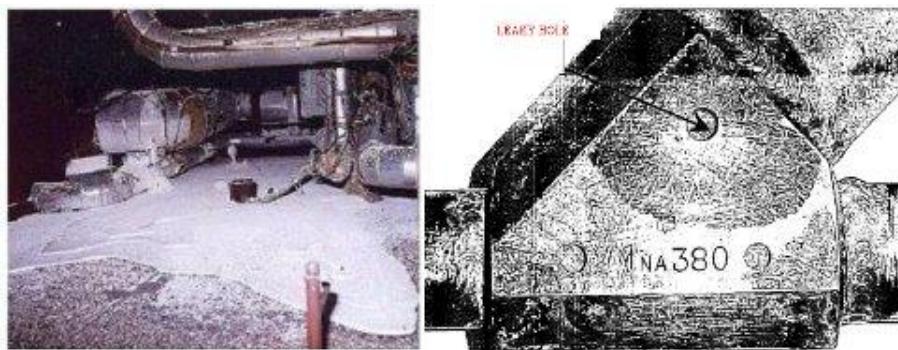
In April 2002, while reactor was operating at 17.4 MWt, there was an incident of leak of 75 kg of primary sodium from the purification circuit. The leaked sodium had frozen on the

cabin floor and pipelines and was manually cut and scooped out under inert gas purging. Leak was from the body of a 20 NB bellows-sealed valve, through one of the three blind holes used by the manufacturer for machining the valve body(Fig 3).

FIG.3 Sodium leak inside purification cabin due to hole in the valve body.

The valve was replaced. Since the problem is generic to the specific make, valves of this make used in the plant were inspected and similarly made valves were rectified by welding tight fit plugs. The sodium which leaked during the incident was converted to hydroxide, neutralized by ortho-phosphoric acid and disposed off as active liquid effluent. It is gratifying to note that a material thickness of just 0.1 mm was enough to hold sodium for 17 years which indirectly indicate the maintenance of high purity level in the Primary sodium system.

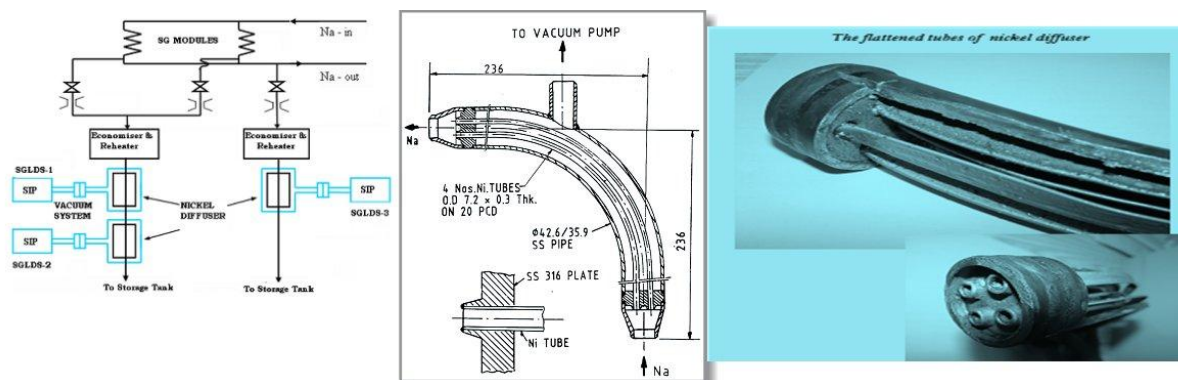
In Feb 2006, there was a reduction in sodium flow in one of the Steam Generator Leak Detection (SGLD) circuit (Fig 4). Heavy accumulation of frozen sodium was found out in the shell side and vacuum line of the nickel diffuser. Sodium has leaked from the tube to tube sheath weld joint of the nickel diffuser and got frozen in the shell side and pipe lines. This compressed and flattened the nickel diffuser tubes resulting in low flow. As no sodium leak detection system was provided in the vacuum lines, the leak has gone unnoticed.

FIG.4 Triplicated SGLDS system and flattened tubes of Nickel diffuser

Hence, Mutual Induction (MI) type probe was provided downstream of the Nickel diffuser in the vacuum line to detect any leak in the initial stage itself.

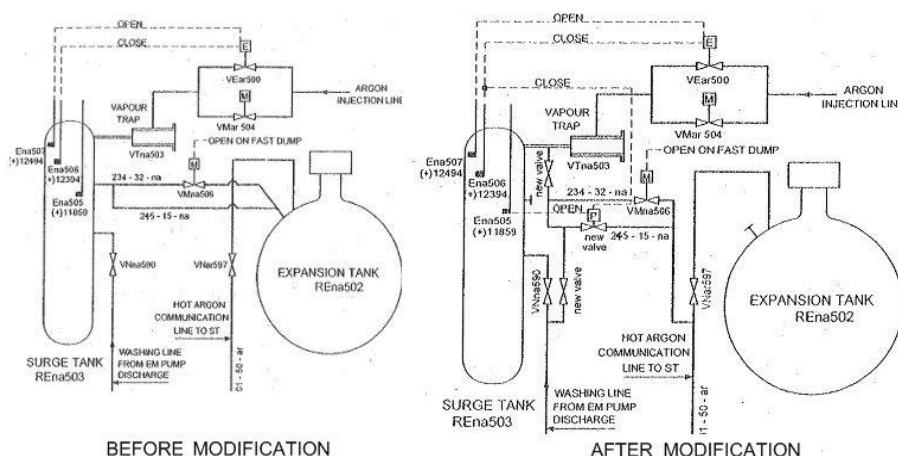
In secondary sodium main circuit, the surge tank remained connected to expansion tank through a communication line with a motorized valve and a bypass line across it (Fig 5). A continuous flow of hot sodium from surge tank to expansion tank maintains this line hot and available for communication whenever needed.

As the hot sodium from surge tank mixes with the cold sodium in expansion tank, there was a possibility of thermal shock in the expansion tank where the hot sodium gets mixed with cold sodium. Identical arrangement existed in French reactor Pheonix and leaks were reported in this location due to thermal stripping. In order to prevent recurrence of such a problem in FBTR, the sodium communication line with integral bypass line was converted to a hot argon communication line by modifying the circuit with a pneumatically operated valve which will open whenever communication is required for level maintenance or for fast dumping.

FIG. 5. Modification in surge tank.

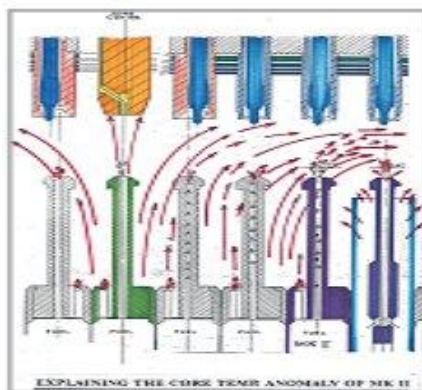
The Core Cover Plant Mechanism (CCPM) has two parts namely a fixed plate housing the thermo wells and a mobile plate housing the sleeves which direct the sodium from the sub assemblies. The mobile plate got struck in the fuel handling position in 1996 and this could not be rectified.

The effect of CCPM struck at 75mm position resulted in a plenum hydraulics where in the hot sodium from the inner rings glided over to cooler sodium from outer rings of the core. Thus the sub-assemblies in the outer ring (third ring on wards) were reading much higher temperatures than the actual temperatures. Theoretical studies indicated that the detectable plugging levels were lower than allowable plugging levels and hence there was no safety concern. An eddy current flow meter was used for periodic checking of actual flow through fuel sub-assemblies during fuel handling state.

FIG.6. Schematic of mixing of streams with CCPM at 80 mm

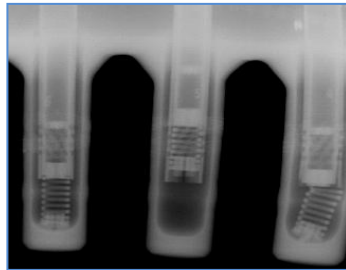
During the operation at 18.6 MWt in the 15th irradiation campaign, large variation was observed among the steam temperatures from the four SG modules. The bulk steam outlet temperature was only 430°C as against 450°C estimated. Investigation revealed dislocation of the spring loaded orifice assemblies (Fig:7) provided at the entry of the water tubes for providing flow stability to the steam generator modules. The spring loaded orifices were replaced with welded type orifices.

Fig:7 Dislocation of orifice in SG

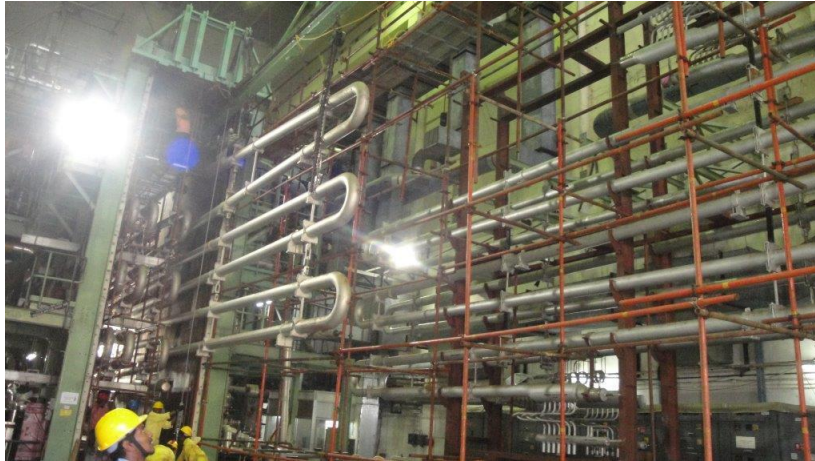
Fig: 8

In each Secondary loop there are two SG modules and there is no individual isolation valves (both water/steam and sodium side) for identification of defective module. Gas tracing technique was employed to ascertain the defective module. In this technique, two different gases namely Helium and Nitrogen/Argon gas were filled at known pressure in the tube side of either modules (injected at the bottom of SG module flow meter tapings) and observed for the presence of Helium or Nitrogen/Argon in the SG shell side. The maximum duration of water/steam leaking into sodium side is estimated to be less than 10 minutes (i.e 3 minutes of transportation delay, 3 minutes for reaching the threshold value from background value for taking SG safe configuration safety action and another

Replacement of defective SG module

3 minutes for SG depressurization). The defective SG module was replaced with spare SG module.
