## Investigation strategy for chemical compatibility study on stainless steel with liquid sodium after in service solicitations: feedback from French Sodium Fast Reactor after 12 years of in power operation

**Key words:** Sodium fast breeder reactor, investigation management, Phénix NPP, Astrid prototype

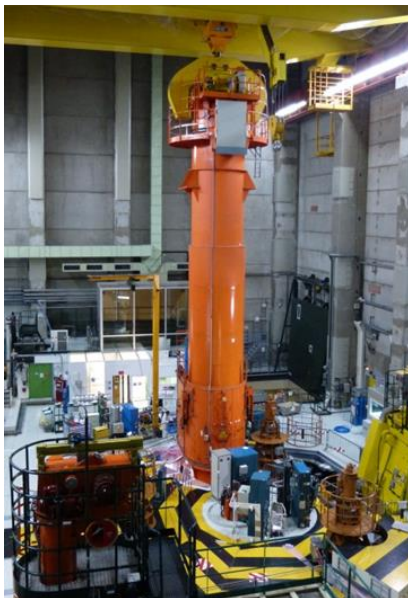
FIG. 4. Extraction of the rod.

The rod had been removed from the reactor core vessel using a handling hood (FIG. 4). Between 2001 and 2012, it remained in a storage pit (FIG. 5) [8]. Once the rod was removed from the reactor, it was transferred into a special cell for the heat insulating jacket to be removed. A radiological mapping of the component was carried out before the washing process to check the possibility of pre-decontamination sampling. Dose rate and contamination results enabled the rod sampling to be performed in 2012 without washing or decontaminating its surface (FIG. 6).

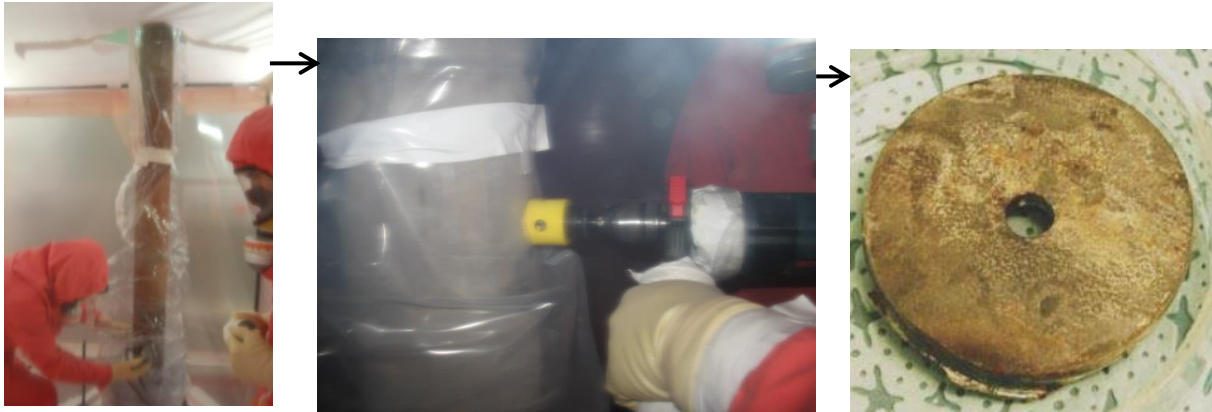
FIG. 6. Sampling in nuclear suit in the work airlock, example of a sample before decontamination (sample #GTEMP-CPML0373-02, red dots, FIG.3).

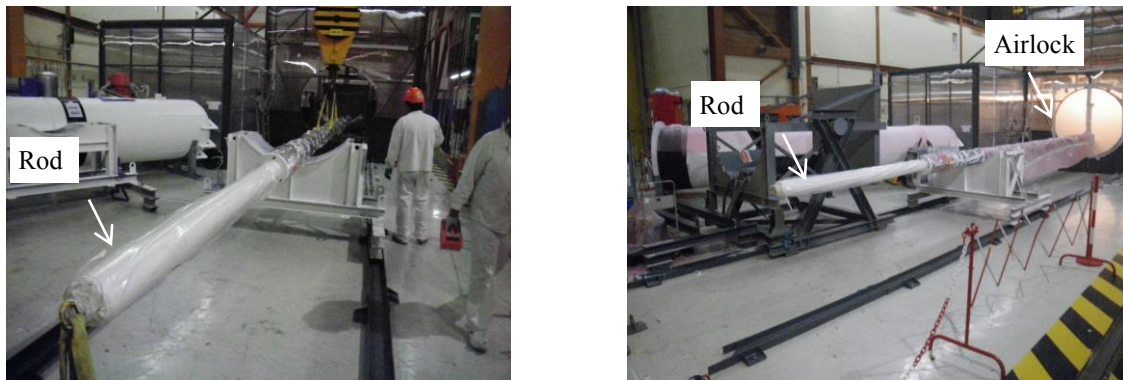
FIG. 7. Work airlock used to sample the rod (views from outside).

Once the samples were taken, the component was transferred to washing pits in order to remove sodium residues. Decontamination baths also helped to significantly reduce the contamination and therefore the surface activity. Sulfuric and phosphoric acids were used, and several decontamination cycles were performed. The component was delivered to the handling hall and tilted using a crane and a specially-designed tilter. After being tilted, the component was inserted into the work airlock and cut with a wire saw (FIG. 7-8).
