## TEM Examination of a Swelling-Resistant Austenitic Steel Irradiated at High Temperature (>600°C) in the Phénix Fast Reactor.

**Abstract.** In the framework of the Sodium Fast-Reactor (SFR) project ASTRID, an optimized austenitic steel 15%Cr-15%Ni, stabilized with Ti, was chosen for the fuel-pin cladding. Besides irradiation swelling, one of the main issue of irradiation is the embrittlement at high temperature (>600°C). To investigate the long-term behavior of this alloy irradiated at temperatures greater than 600°C, fuel pins clad with optimized Si-enriched 15-15Ti, were irradiated in several experimental assemblies of the Phénix reactor to reach a cumulative irradiation time of 941 days (EFPD Equivalent Full Power Day). Thin foils suitable for Transmission Electron Microscope (TEM) were taken from the upper part of the fuel pin where the irradiation temperature is maximum and exceeds 600°C. The final dose of the irradiated thin foil is about 40 dpa NRT. TEM observations were carried out to characterize irradiation defects, dislocation network and precipitations in order to identify the possible embrittlement mechanisms. TEM examinations show significant dislocation recovery b

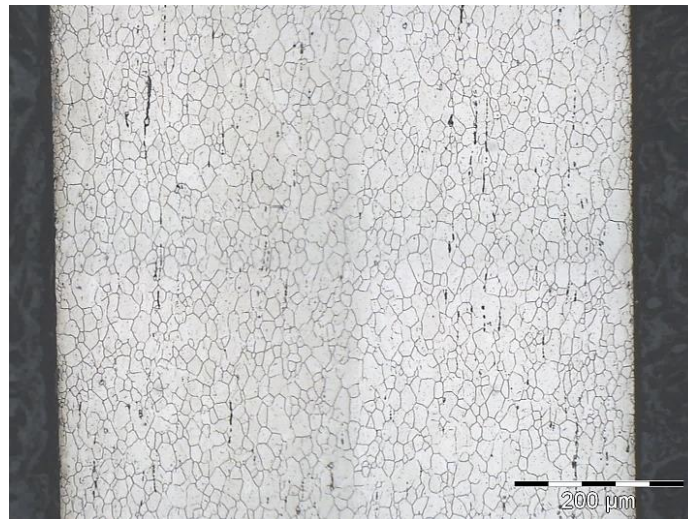
FIG. 1. Metallography of the cladding showing austenitic grains and primary carbide precipitates.

After the last solution-annealed treatment, the final geometry of the tube (outer diameter 6.55mm and thickness 0.45mm) was achieved by cold drawing (cold-working level of 23%). No thermal treatment was performed after the cold deformation step. The chemical composition directly measured in the tube is given in TABLE 1. The composition leads to a fully austenitic structure (grain size 20  $\mu\text{m}$ ) without ferrite. Only primary TiMo(C,N) nitrocarbides are present in the microstructure. Alignment of primary precipitates in the drawing direction are visible in the metallography displayed in FIG. 1.

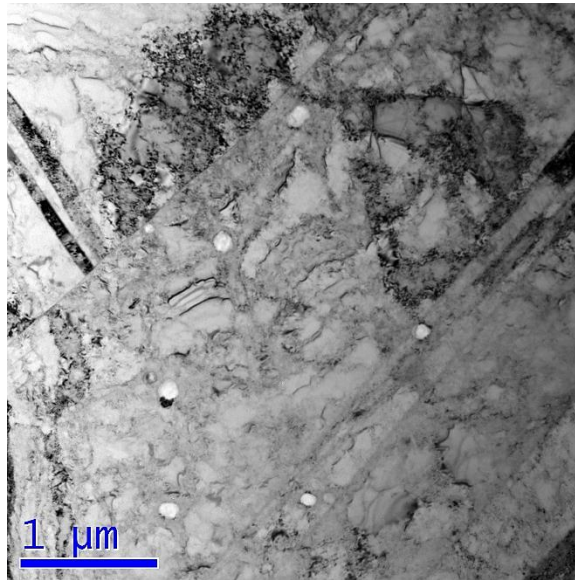
*FIG. 2. Bright-field TEM image showing the general microstructure before irradiation with high dislocation density, twins and few dislocation cells as well as primary Ti-Rich MC precipitates.*

TEM examination before irradiation shows a high dislocation density and mechanical twins due to the 20% cold working (See FIG. 2.). Induced by the cold deformation, local rearrangements of dislocations into cells are observed. Only primary TiMo(C,N) precipitates are present and no nanoprecipitates of rich-Cr carbides were detected.

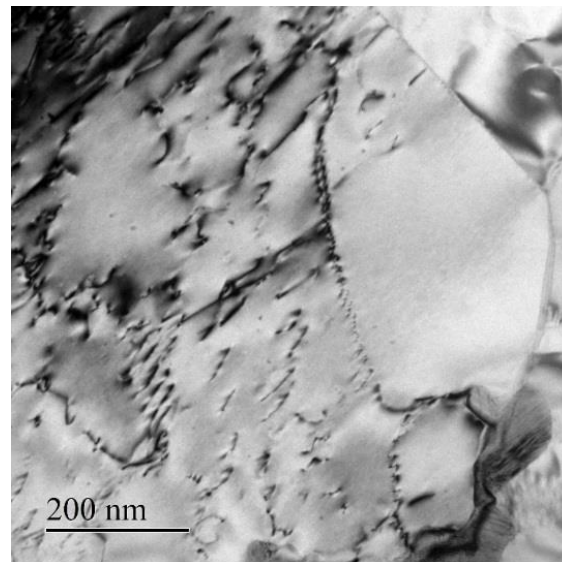
FIG. 3. TEM bright field image of dislocations microstructure showing rearrangement due to recovery mechanisms.

**Dislocation network** A possible high-temperature issue of cold-worked Ti-stabilized steels is the risk of extensive recovery and possibly radiation-induced recrystallization during service life. Studies suggest that 15-15Ti alloys with high Si can recrystallize at a lower temperature than under thermal aging [1]. In the present examination, extensive primary recrystallization did not occur. However recovery mechanisms are clearly visible and caused a decrease of dislocation density. Rearrangement of dislocations and creation of free dislocation cells with a uniform TEM contrast is shown in FIG. 3. This dislocation-free zones are often formed at triple-junction points and could act as recrystallization nuclei.

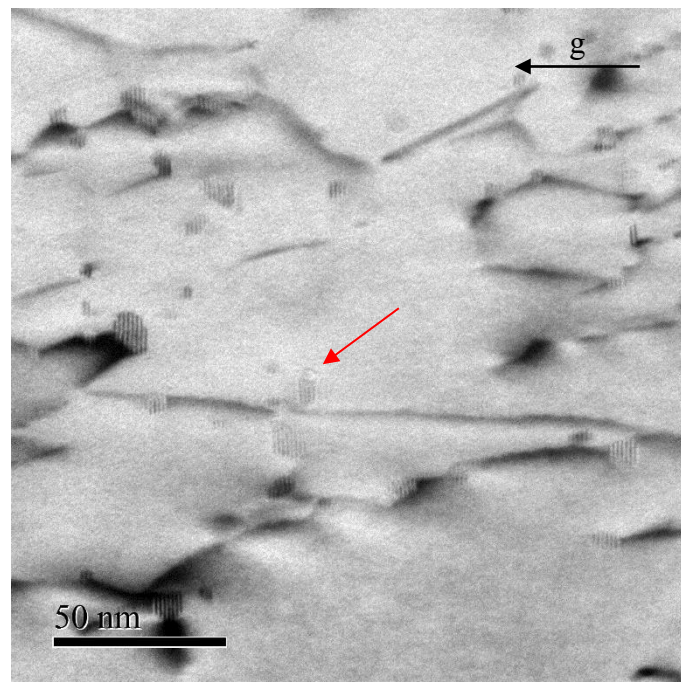
FIG. 4. TEM image of nanoprecipitates MC (Moiré fringes) in bright field condition with diffracting vector  $\mathbf{g}=\langle 002 \rangle$ . Red arrow shows a small bubble nucleated at the TiC-matrix interface.

**Nanoprecipitation** Ti-stabilized alloys were designed to create a fine dispersive precipitation of Ti-rich MC precipitates when exposed to a high temperature thermal treatment. As shown in FIG. 4, MC were identified in bright field condition using the Moiré fringes (caused by the slight difference in the Fm3m lattice parameter between the precipitates and matrix) with a diffraction vector  $\mathbf{g}=\langle 002 \rangle$ . In this condition, the measured average spacing of the Moiré fringes gives a MC lattice parameter of  $a_0 = 0.42$  nm (assuming matrix lattice parameter  $a_0 = 0.36$  nm measured in the unirradiated sample). As in thermal treatments, the nucleation of MC is clearly enhanced in dislocations. The MC nanoprecipitation is homogeneously distributed in the sample.

**Bubbles and vacancy clusters:** small bubbles are visible inside matrix grains and in grain boundaries (see FIG. 6.). Some bubbles also nucleate heterogeneously at nanoprecipitate surfaces (FIG. 4) and at interfaces between matrix and larger precipitates (FIG. 7). The presence of large cavities (vacancy clusters) is not expected at 600°C because of the high probability of thermal dissociation. The stable bubbles observed in the present work are more likely helium bubbles. The helium generation rate in the upper part of the cladding is between 0.2 and 0.5 appm/dpa (due to  $n,\alpha$  reactions). In the literature [3], the formation of helium bubbles at grain boundaries is believed to contribute to the embrittlement of irradiated austenitic steels at high temperature (reduction of ductility in tensile test, reduction of rupture time in creep test). Note that very few studies with neutron-irradiated samples directly show the presence of helium bubbles. Most of the data come from helium-implanted samples or indirect correlations between creep properties and helium content.

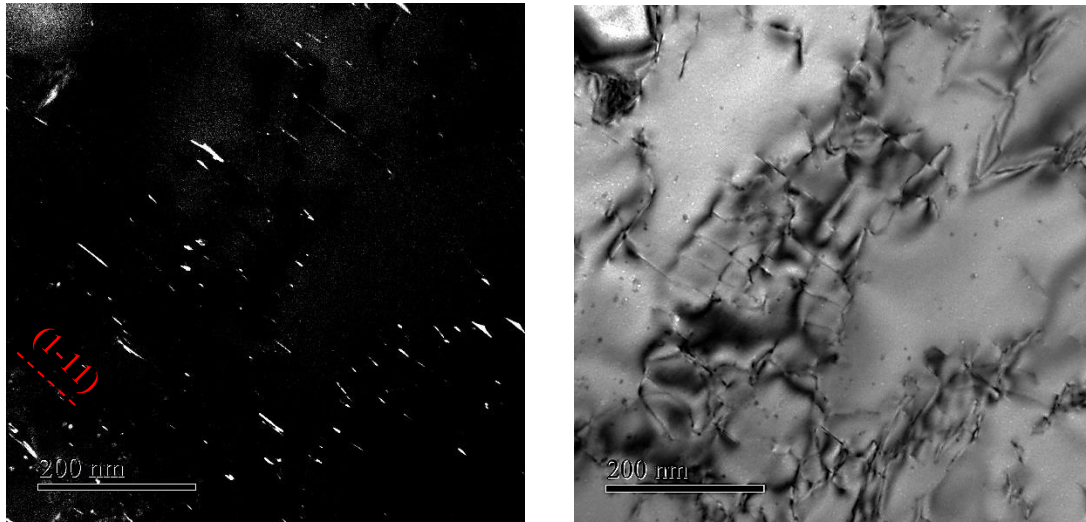
FIG. 5. Dark field TEM image with the rel-rod technique of Frank loops (1-1) in two-beam condition  $B=[110]$   $g=<-113>$  (left Figure) and the corresponding bright field image (right Figure)

**Frank loops** Faulted Frank loops were identified in dark field images by the rel-rod technique (see FIG. 5). The largest loops reach 60 nm in size. Larger faulted loops are not present because they are unstable and tend to unfault. Frank loops are homogeneously present in the sample, except inside free dislocation cells indicating that recovery process eliminates Frank loops.

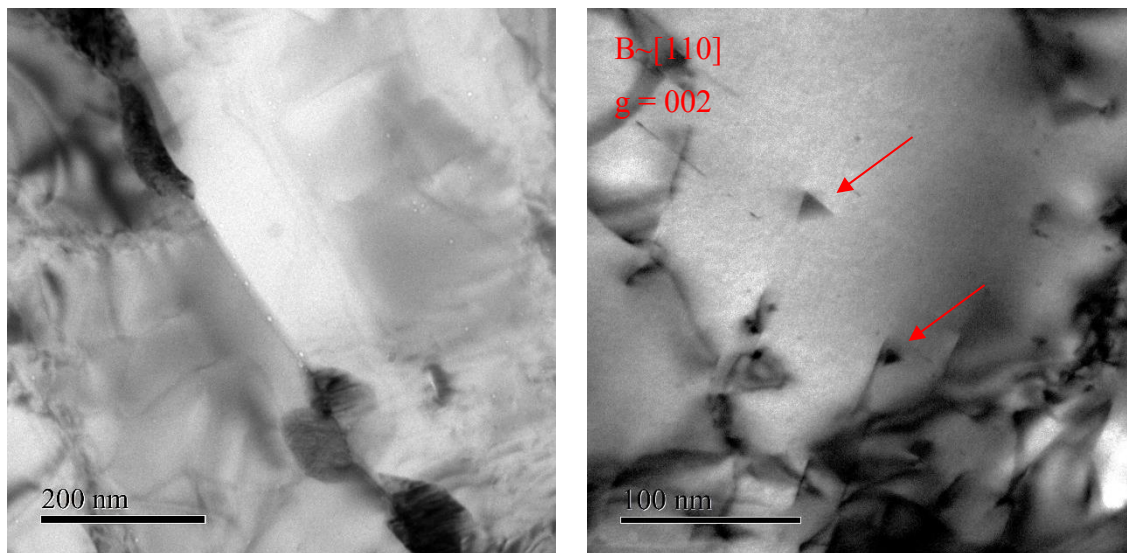
FIG. 6. TEM bright field image showing intergranular bubbles between precipitates (left figure) and triangular-shaped defects, (right figure) indicated by the red arrows.

Triangular-shaped defects with a rather low density are also observed with sample oriented in two beam condition  $B=[110]$   $g=<002>$  as shown in FIG. 6. Triangular-shaped contrasts in TEM image can be the result of overlapping defects in the electron beam direction. Stacking Fault Tetrahedra (SFT) have also a similar contrast but were rarely observed in commercial steels irradiated at 600°C [2]. Further examinations are needed to determine the nature of these defects.

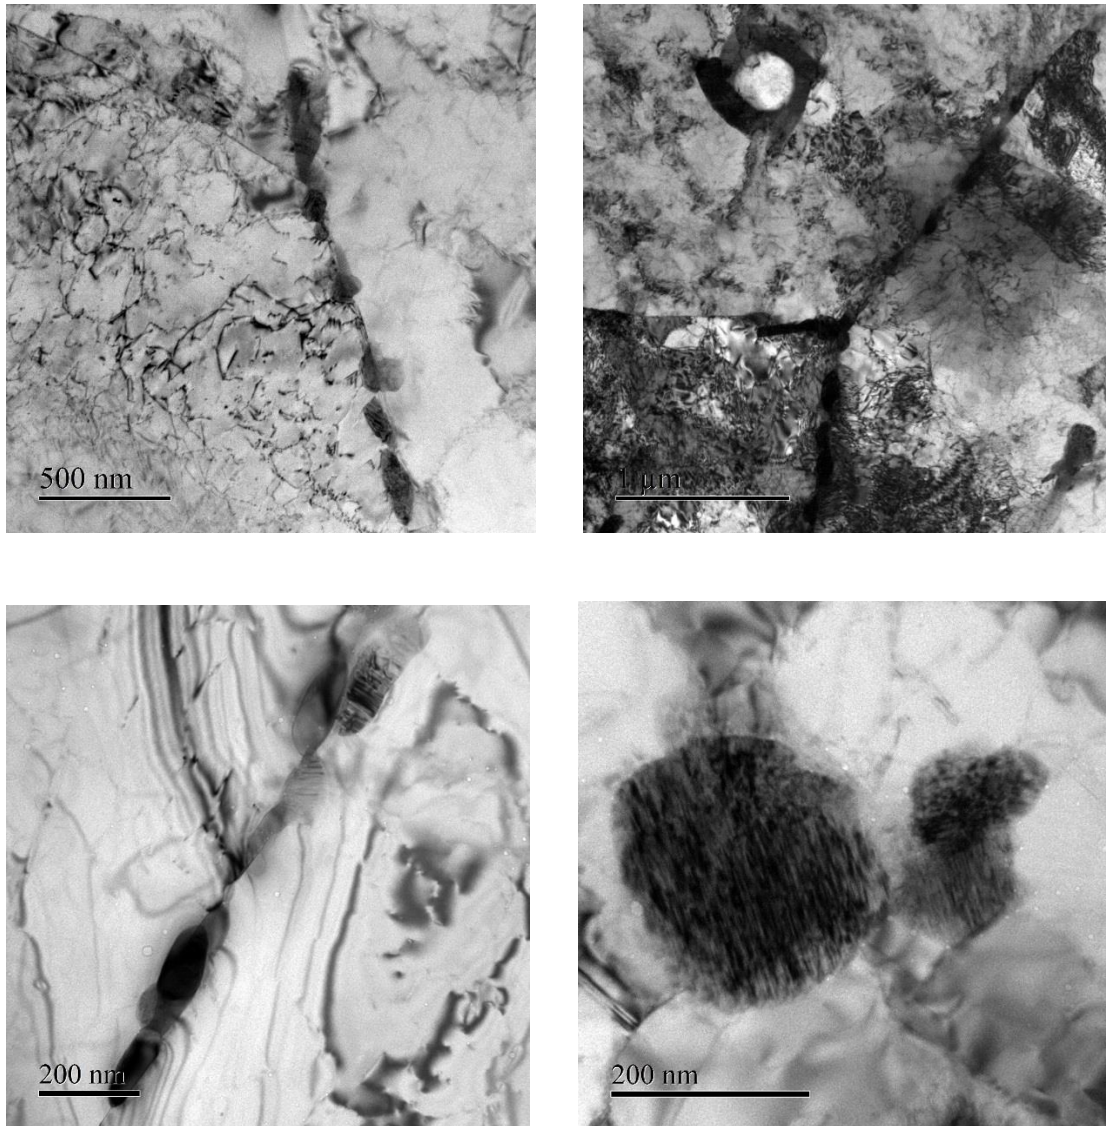
*FIG. 7. Overview of coarse intra and intergranular precipitates. Note that precipitate surfaces promote bubble nucleation.*

**Intergranular precipitation:** One of the striking feature of the irradiated microstructure is the abundant presence of intergranular precipitates as displayed in FIG. 7. Coarse precipitates are also formed around primary MC, inside matrix grains. Several types of precipitates coexist as indicated by EDS (Energy Dispersive X-ray Spectroscopy) analysis in FIG. 8. Compared to the matrix, one type of precipitates is enriched in Ni, Ti and Si which is consistent with the G phase composition [4]. Another family of precipitates is enriched in Mo and Si (Si/Mo  $\sim$ 0.5). This type of precipitate contains a high density of stacking faults as observed on the bottom-right image of the FIG. 7. Above 600°C, the literature for Ti-stabilized austenitic steel reports the formation of laves phases (Hexagonal structure with space group  $P6_3/mmc$ ) with high Mo contents and appearing as faulted laths. M<sub>6</sub>C (space group  $Fd\bar{3}m$  diamond cubic) and G phases (fcc structure with space group  $Fm\bar{3}m$ ) are also commonly observed. Selected Area Diffraction (SAD) studies are in progress to identify the crystallographic structure of the precipitates and to confirm their nature.

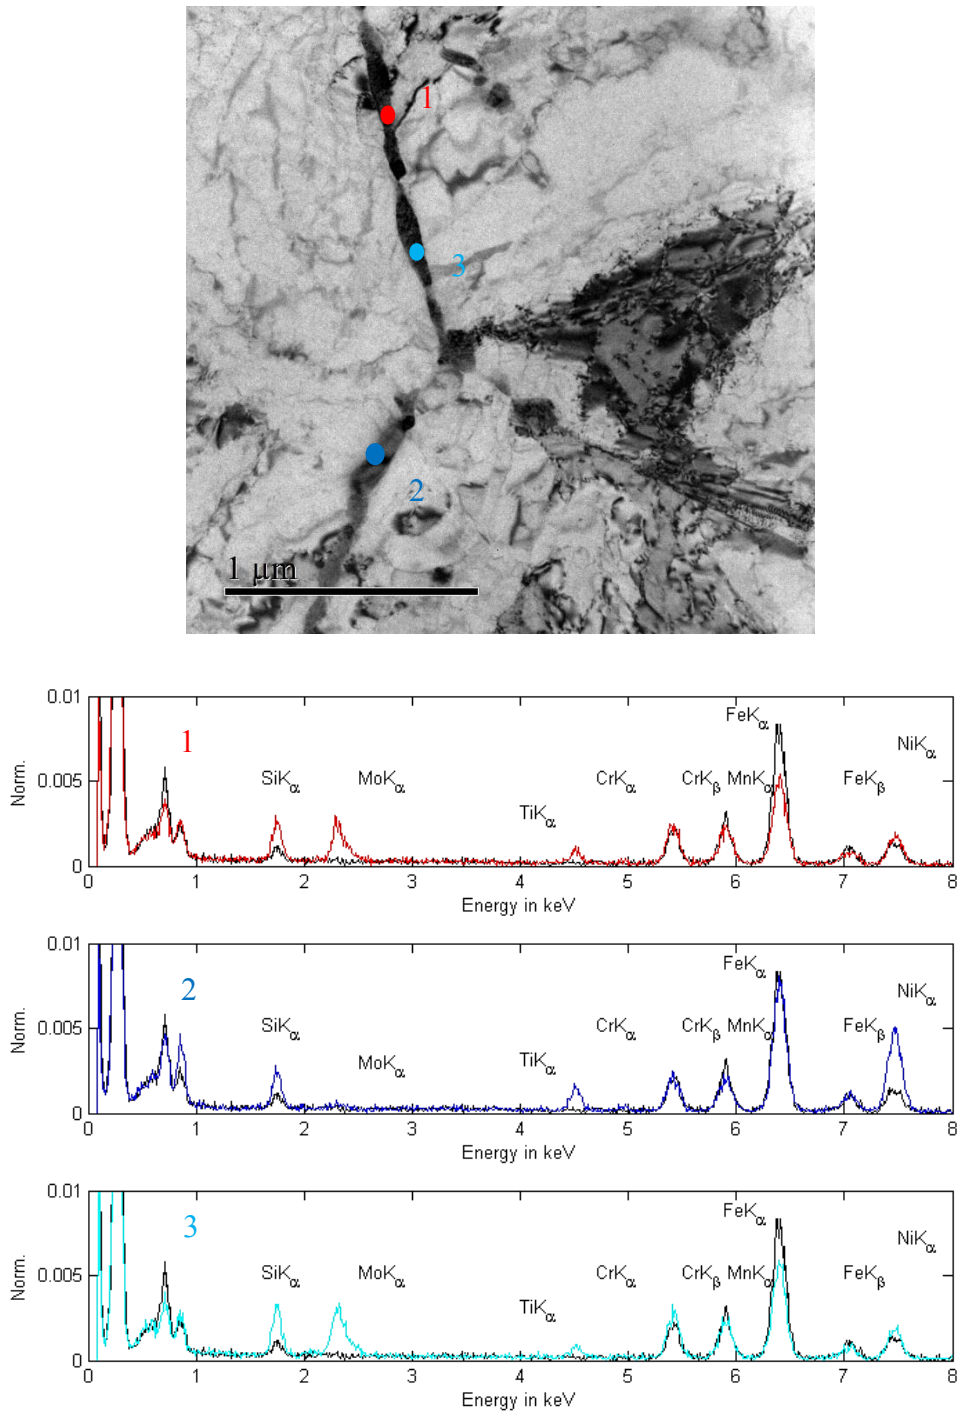
FIG. 8. EDS Spectrum of matrix (black curves) compared with several EDS spectra of precipitates (color curves). Spectra are not corrected for Mn radioactivity.
