Operating Experiences of FBTR

Indira Gandhi Centre for Atomic Research (IGCAR), Kalpakkam, India

Abstract:

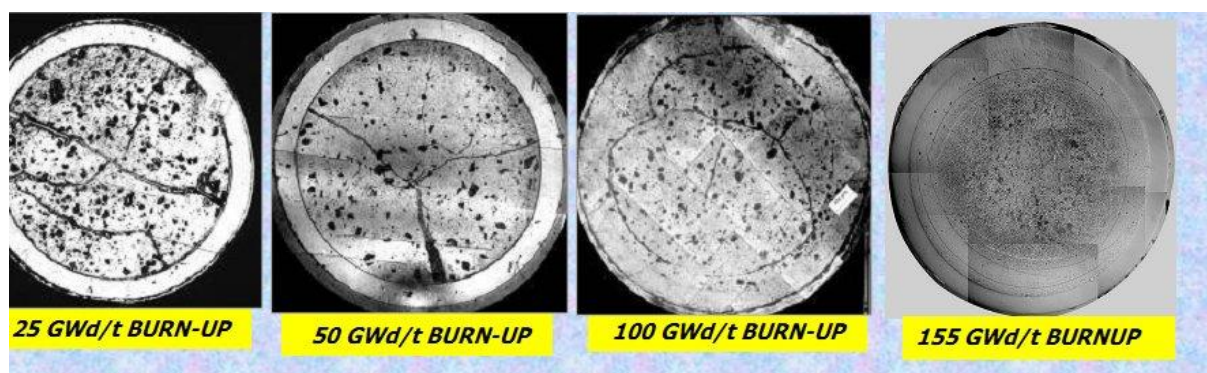
Fig 2 .Micrographs of MK-1 fuel at different burn up level

The lead Mark I fuel (70% PuC+30% UC) subassembly was irradiated upto the burn up of 1,65,000 MWd/t without fuel clad failure. The fuel has also been successfully reprocessed at IGCAR. The successful closure of the fuel cycle was also demonstrated when a fuel subassembly with Pu recovered from FBTR fuel was loaded back into the core of FBTR.

During PIE, the measurements at different locations indicated that the apparent gap had reduced from average pre-irradiation value of 75-110 microns to uniformly around 20 microns in all the locations. The gap reduction during beginning of life indicates the feasibility of increasing the LHR of PFBR fuel to the design value of 450 W/cm after the initial pre-conditioning of approximately 20 EFPD.
